Chocolay Township

Signalized intersection locations on US-41/M-28 with crash summaries and collision diagrams for the years, 2000, 2001 and 2002.

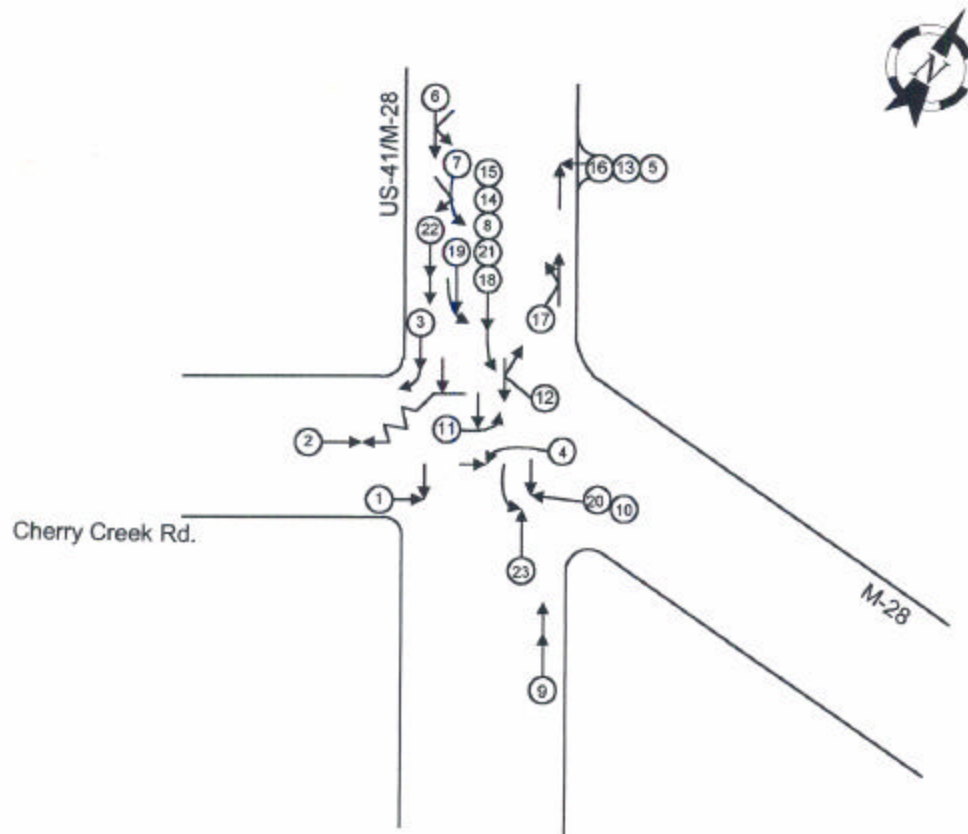
US-41/M-28 at M-28/Cherry Creek Rd
Chocolay Twp., Marquette County
Years 2000, 2001 & 2002
Collisions Supplement Sheet

Of the 23 crashes, 9 were southbound to eastbound left-run collisions. An intersection operations study is recommended to provide safer left-turn opportunities.

Three years of Collisions - 2000 thru 2002

23 Total Collisions - 18 Property Damage, 4 injury, 1 Unk
 9 Left Turn related (SBd to EBd), 5 Rear Ends, 1 Head-on
 Left Turn, and 3 Side swipe

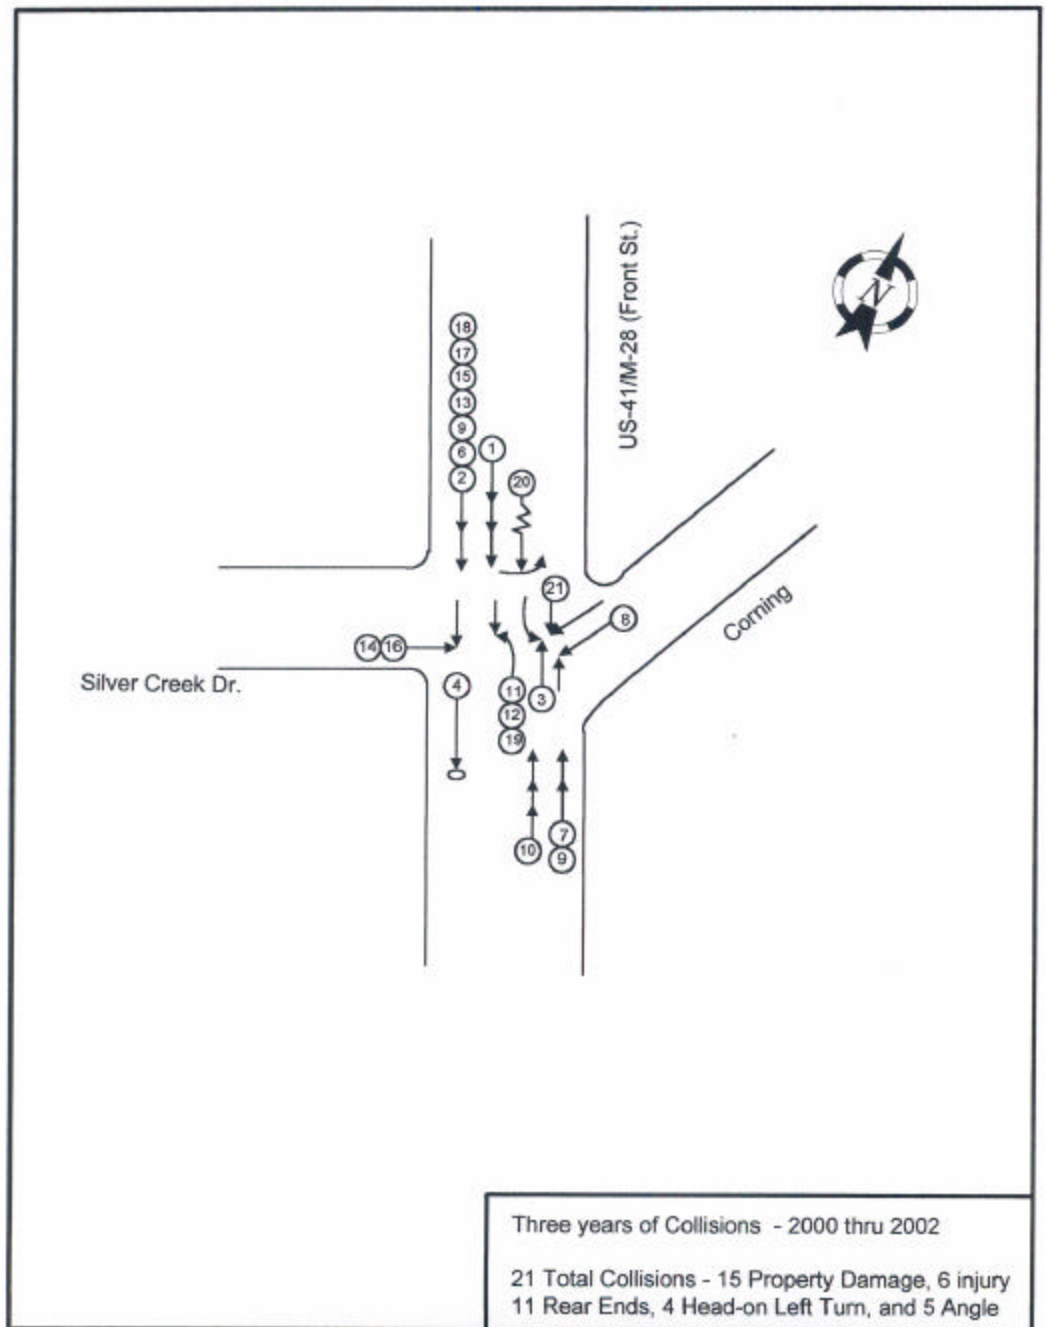
US-41/M-28 at Silver Creek Rd
 Chocolay Twp., Marquette County
 Years 2000, 2001 & 2002
 Collisions Supplement Sheet

Eight of the 21 crashes were southbound rear ends, 5 were angle and 4 were head on left turn crashes. Visibility of the signal is questioned by the local agency. Improved clearance intervals may reduce left turn crashes.

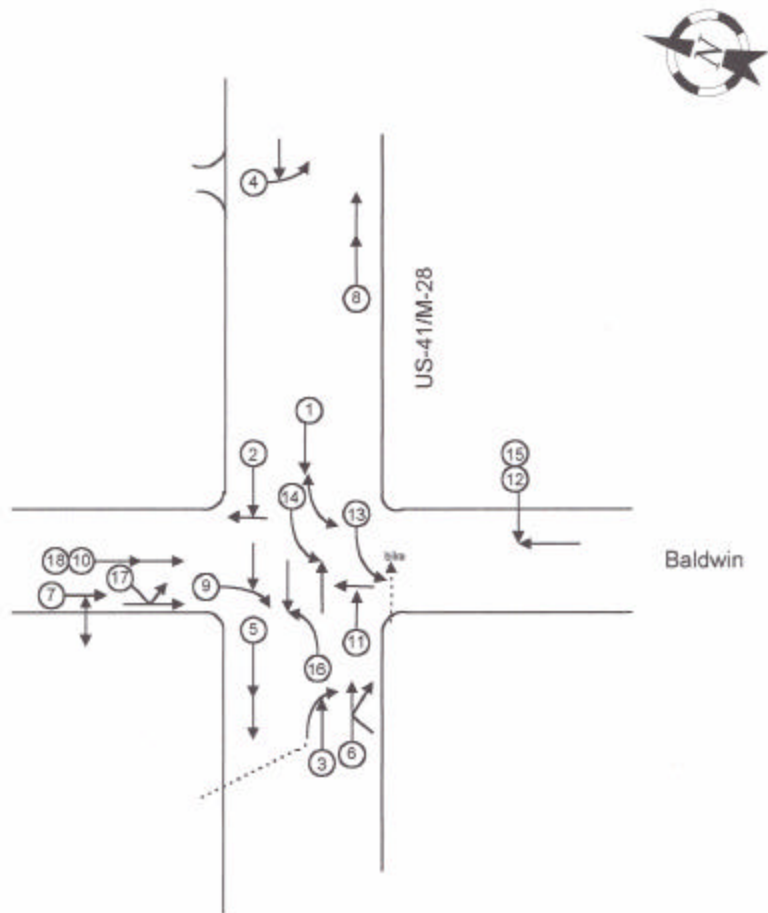
US-41/M-28 at Baldwin St.
City of Negaunee, Marquette County
Years 2000, 2001 & 2002
Collisions Supplement Sheet

Eighteen [18] of the crashes were angle collisions. The turning movements at this intersection should be studied further.

Three years of Collisions - 2000 thru 2002

18 Total Collisions - 14 Property Damage,
4 injury - 6 injured
